The Commonwealth of Massachusetts Executive Office of Health and Human Services Department of Public Health 250 Washington Street, Boston, MA 02108-4619

March 9, 2004

At the request of Mary Zamorski, Nursing Supervisor, Springfield School Department, the Bureau of Environmental Health Assessment (BEHA) conducted an evaluation of the indoor air quality at the Gerena Magnet School (GMS), 200 Birnie Avenue, Springfield, Massachusetts. As you may know, on February 13, 2004, I conducted this evaluation and was accompanied by Judy Deane of the American Lung Society of Western Massachusetts and Ms. Zamorski. Concerns about the conditions within the special needs student classroom prompted the request. The indoor air quality assessment included the main GMS building as well as occupied areas of the underground complex beneath the GMS. The special needs student classroom is located in a section of the underground complex referred to in this letter as the GMS Annex (the Annex).

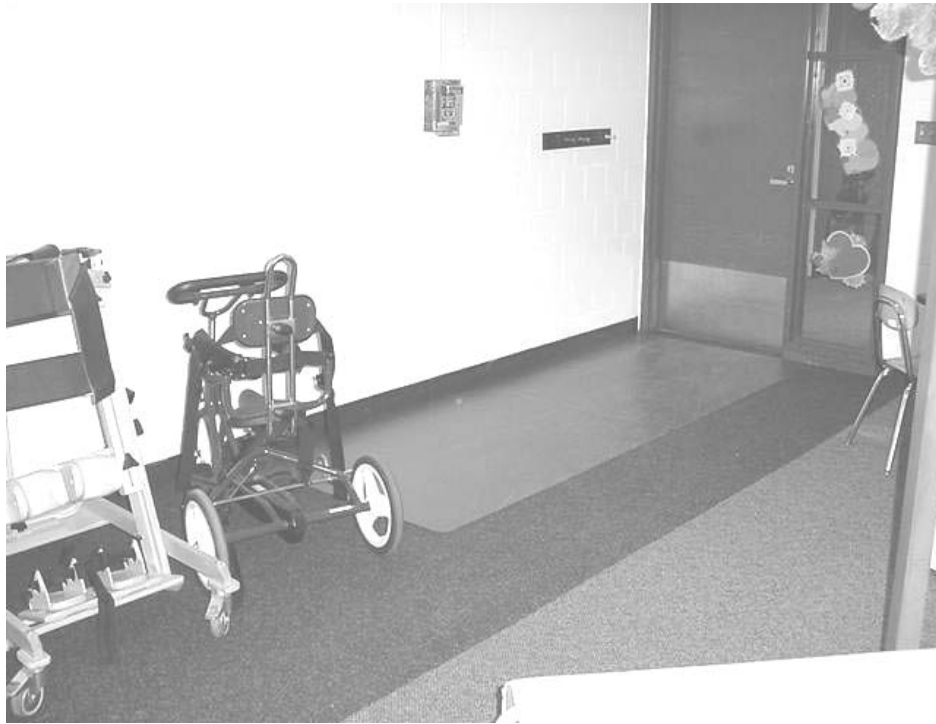
Picture 1

During the course of the our assessment, a musty odor was detected in the special needs student classroom. Carpeting in this area near a hallway door was examined and found to be moistened with water (Picture 1). It appears that this section of carpet was previously replaced due to its different color from the rest of the wall-to-wall carpet in this area. A plastic walk off mat was observed on top of this carpeting. The plastic walk off mat is made of a water impermeable material, which prevents the carpet underneath it from drying. Carpeting is manufactured from porous materials that may serve as media for mold growth. Please note that the US Environmental Protection Agency and the American Conference of Governmental Industrial Hygienists (ACGIH) recommend that porous materials (such as carpeting) be dried with fans and heating within 24-48 hours of becoming wet (US EPA, 2001; ACGIH, 1989). If porous materials are not dried within this time frame, mold growth may occur. Water-damaged porous materials cannot be adequately cleaned to remove mold growth. The application of a mildewcide to moldy porous materials is not recommended. The plastic walk-off mat prevent drying, which has resulted in the carpeting remaining wet for extended periods of time and is likely colonized with mold.

The most likely cause of carpet moistening is water penetration from the wall adjacent to the carpets edge. The special needs classroom is constructed in a section of the Annex that was built within a space created by a bridge that is part of the Interstate 91 highway (I-91). This classroom is located beneath an I-91 exit ramp (Picture 2). It appears that the wall prone to water penetration is in direct contact with soil beneath the I-91 off-ramp, which becomes saturated after rainstorms or snow plowing.

Special Needs Classroom Moistened Carpet

Building occupants confirmed that this section of the floor is prone to moistening. Any floor surface that is prone to standing water or moistening due to condensation generation should not be carpeted. In addition, the wall coving (Picture 3) at the wall-carpet junction consists of a water impermeable material. Water can accumulate behind the wall coving which can then chronically moisten the coving adhesive. The glue used to adhere the coving to the wall may serve as a mold growth medium. In this instance, carpeting that is chronically moistened should be removed. In addition, the wall coving in the area of moistened carpet should also be removed. Once the carpeting and coving is removed, this section of floor and wall should be observed to gauge the extent of water penetration through the wall. Excessive water should be mopped from the floor as needed. It is suggested that this section of floor be left bare to prevent further mold growth.

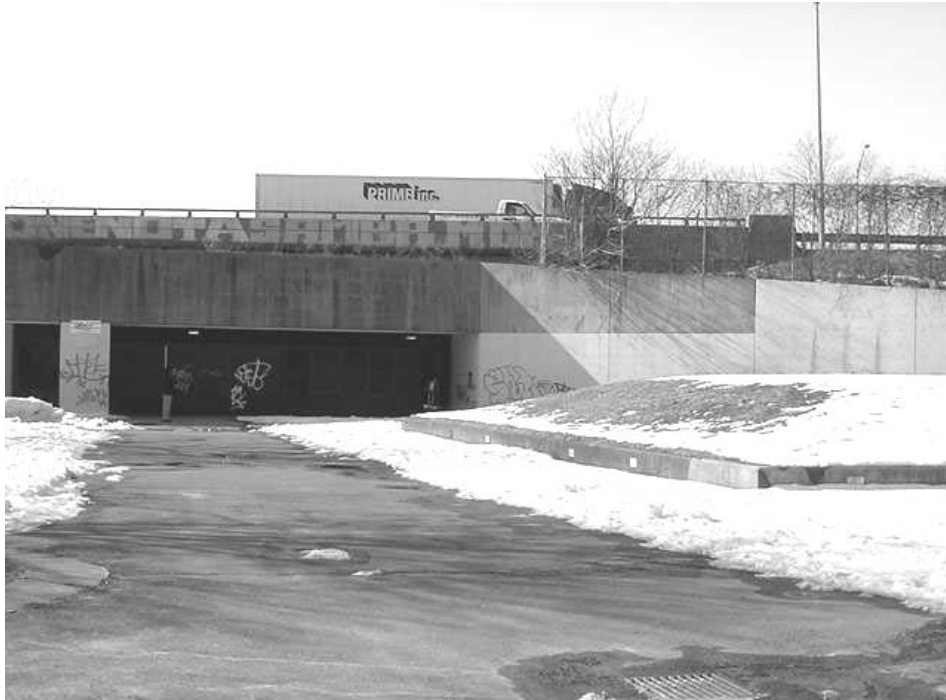
Picture 2

Exterior of the GMS Annex (Note Bridge and Trees Growing in Soil, Which Were above The Areas That Had Water Penetration)

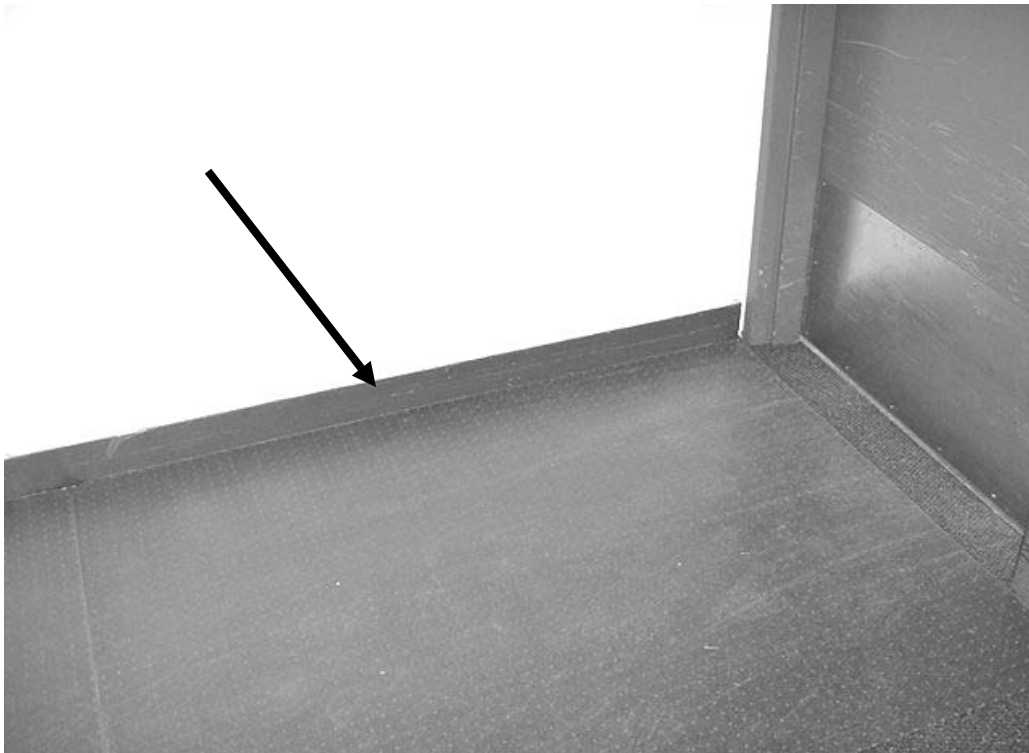
Picture 3

Wall Coving At Base of Wall Next To Moistened Carpet

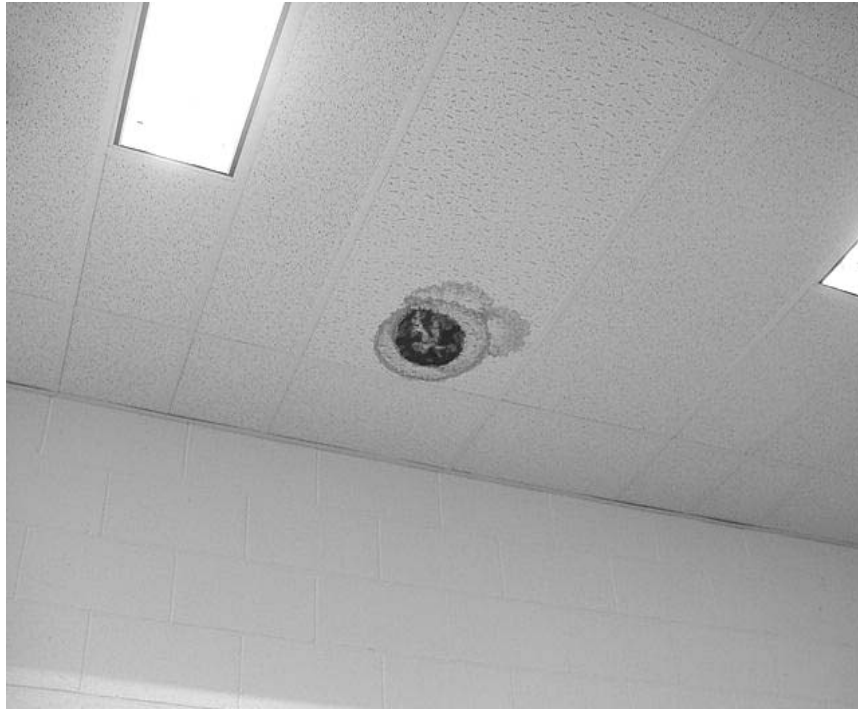
Picture 4

Finally, of note was a musty odor noticed upon entering the GMS media center mezzanine. This odor was found more pungent upon entering the pod area below the media center. In the ceiling beneath the media center was a ceiling tile that was colonized with mold (Pictures 4 and 5). BEHA staff tried to ascertain the source of water that had moistened this tile, but could not identify the water source. It is recommended that the ceiling tile be removed and the source of water causing the water damage be repaired.

Mold Colonized Ceiling Tile above the Media Center Pod

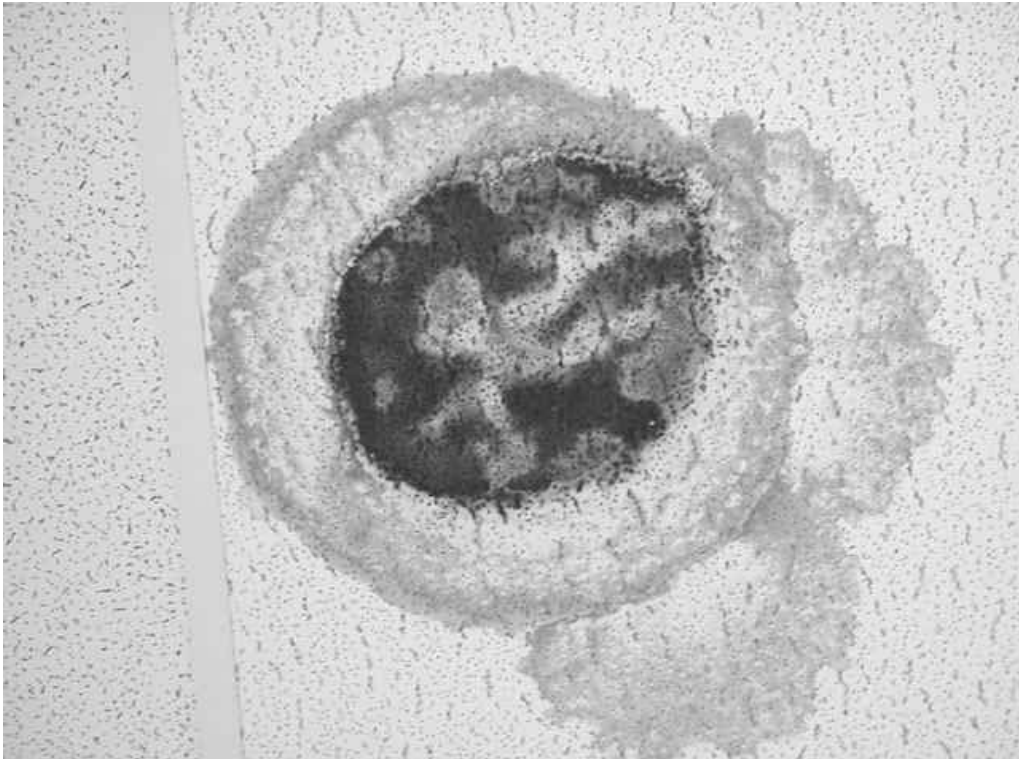
Close-Up of Picture 5
